UNITED STATES  
DEPARTMENT OF THE INTERIOR  
BUREAU OF MINES

Subject: Report on investigation of minor coal-mine bump, No. 9 mine,  
Jewell Eagle Coal Company, Melville, Logan County, West Virginia,  
September 22, 1959

Sketch No. 1

Mountain Bump, 1 Butt Left Chain Pillars  
No. 9 mine, Jewell Eagle Coal Company  
Melville, Logan County, West Virginia  
Sketch No. 2 September 22, 1959

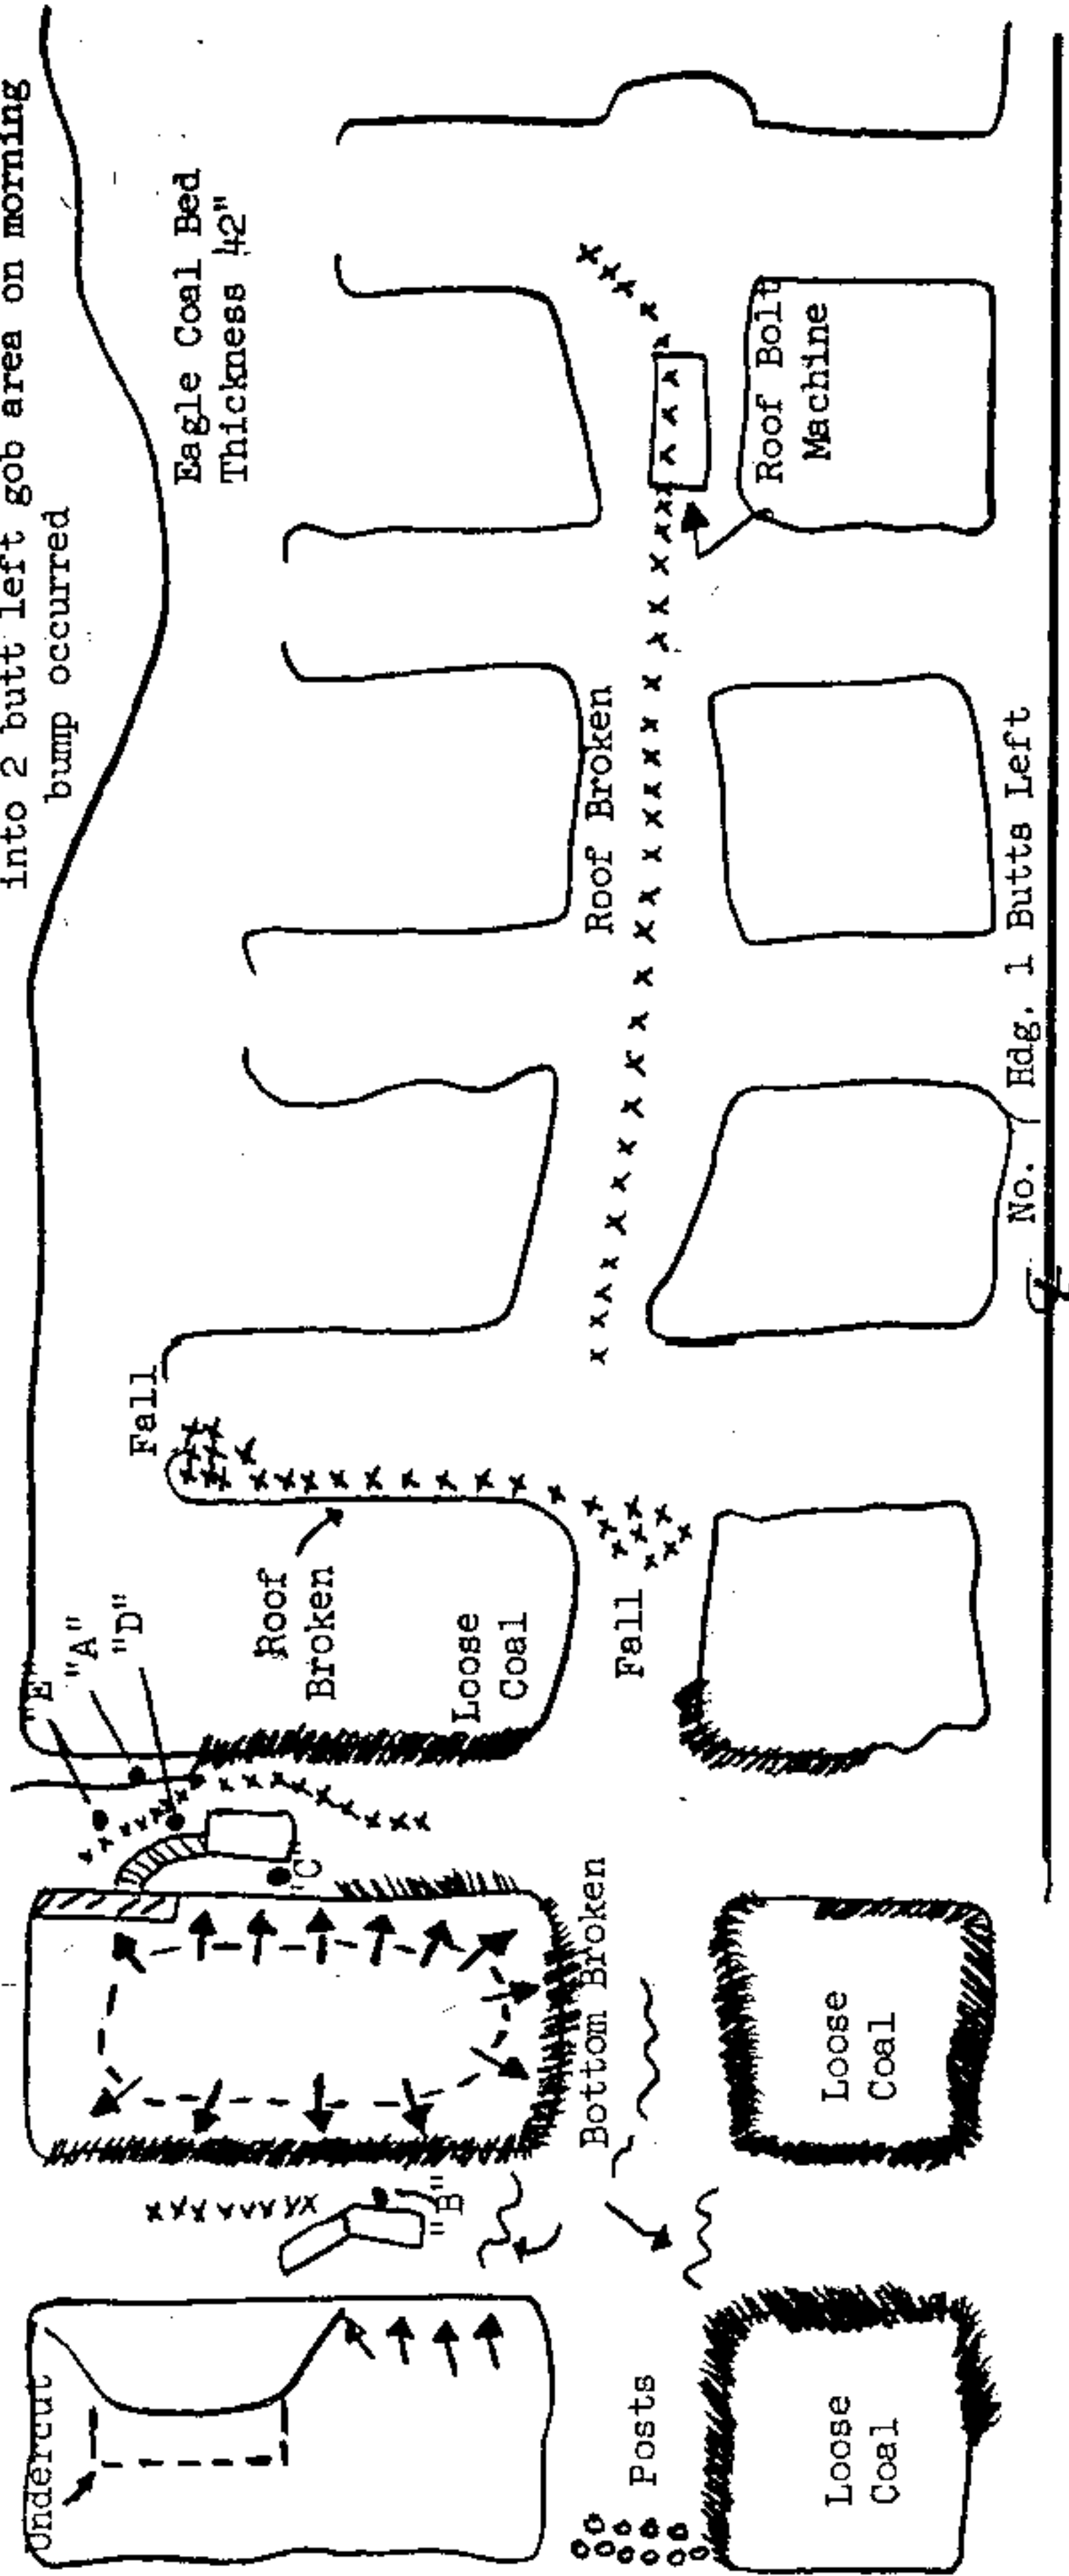
The 1 butt left room panel barrier block had been reduced to 400 feet in length, and the last 6 rooms had been turned and were developed as indicated in Sketch 1, when the bump occurred. Location of the men and equipment is also shown in Sketch 1. It will be noted that the Nos. 1 and 2 rooms had holed through on the day of the bump into the old 2 butt left gob; and the second cut had been made in the No. 1 room pillar. Numbers 3 and 5 rooms lacked about 20 feet and Nos. 4 and 6 rooms lacked 30 to 40 feet of cutting into the 2 butt left goaf. At the time of the bump the faces of Nos. 3, 4, 5 and 6 rooms were cleaned up. The second cut had been made in the pillar lift in No. 1 room pillar and the cutting-machine crew had moved the cutting machine back to permit drilling the face preparatory to blasting.

The loading machine crew had been instructed to start a pillar lift in the No. 2 room pillar, as indicated in Sketch 1. They removed the timbers on the left side at the location where the lift was to be started, and according to the foreman, were loading the third shuttle car of coal along side of the pillar when the outburst occurred. The reaction of the outburst (stress wave) thrust the loading machine sidewise reportedly about 8 feet and approximately 12 to 15 tons of coal were thrown from the side of the pillar adjacent to the loading machine. The loading machine was the only equipment in operation in the face areas at the time the bump occurred. The 4 employees, none of whom were covered by the outrush of coal, evidently were injured by flying coal and/or by being thrown against the coal or equipment. The section foreman who was sitting on the right side of the roadway opposite the loading machine observing the loading operations, (See Sketch 1) was not injured.

Effects of the bump were evident in 5 of the 6 rooms, but the greatest forces, however, were concentrated in the area comprising the last inby pillars of Nos. 1 and 2 rooms, with the greatest forces being expended in the inby pillar of No. 2 room, causing cavities or spaces 4 to 6 inches in height extending as much as 6 feet within each side of the pillar. The shock from the ultimate failure of the No. 2 room pillar was sufficiently intense to cause coal to be expelled from the periphery of the inby pillars of Nos. 1, 2, and 3 rooms, as indicated in sketch 1.

14 BU Joy Loading Machine thrust 8' outward by force of bump

Note: Nos. 1 and 2 rooms cut through into 2 butt left gob area on morning bump occurred

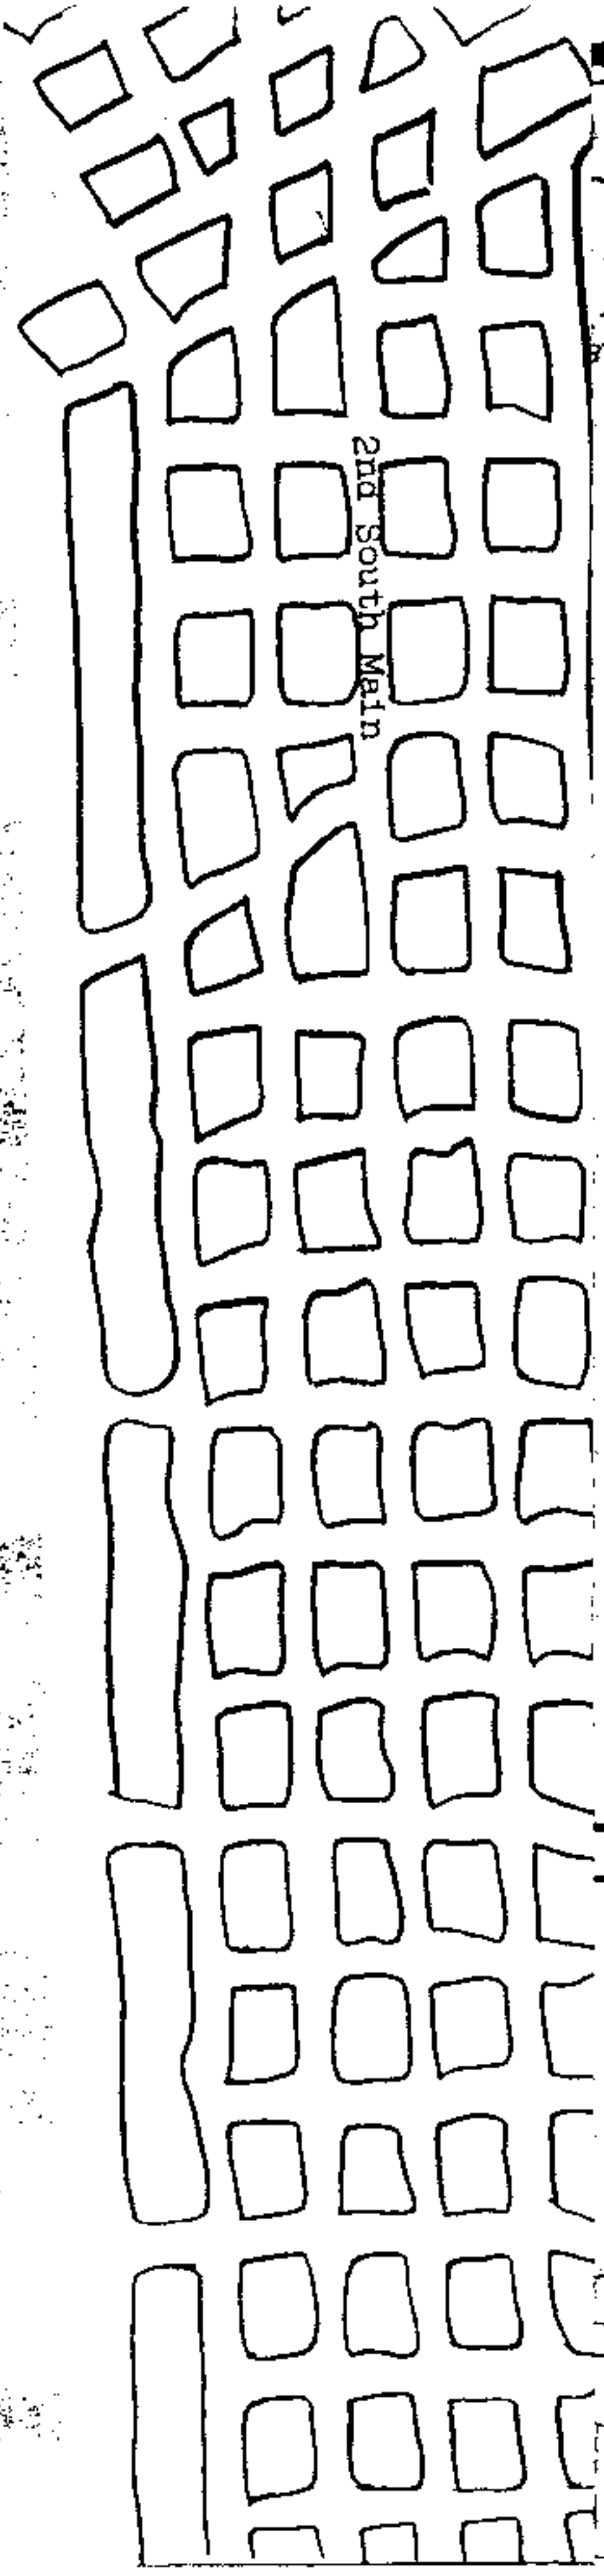
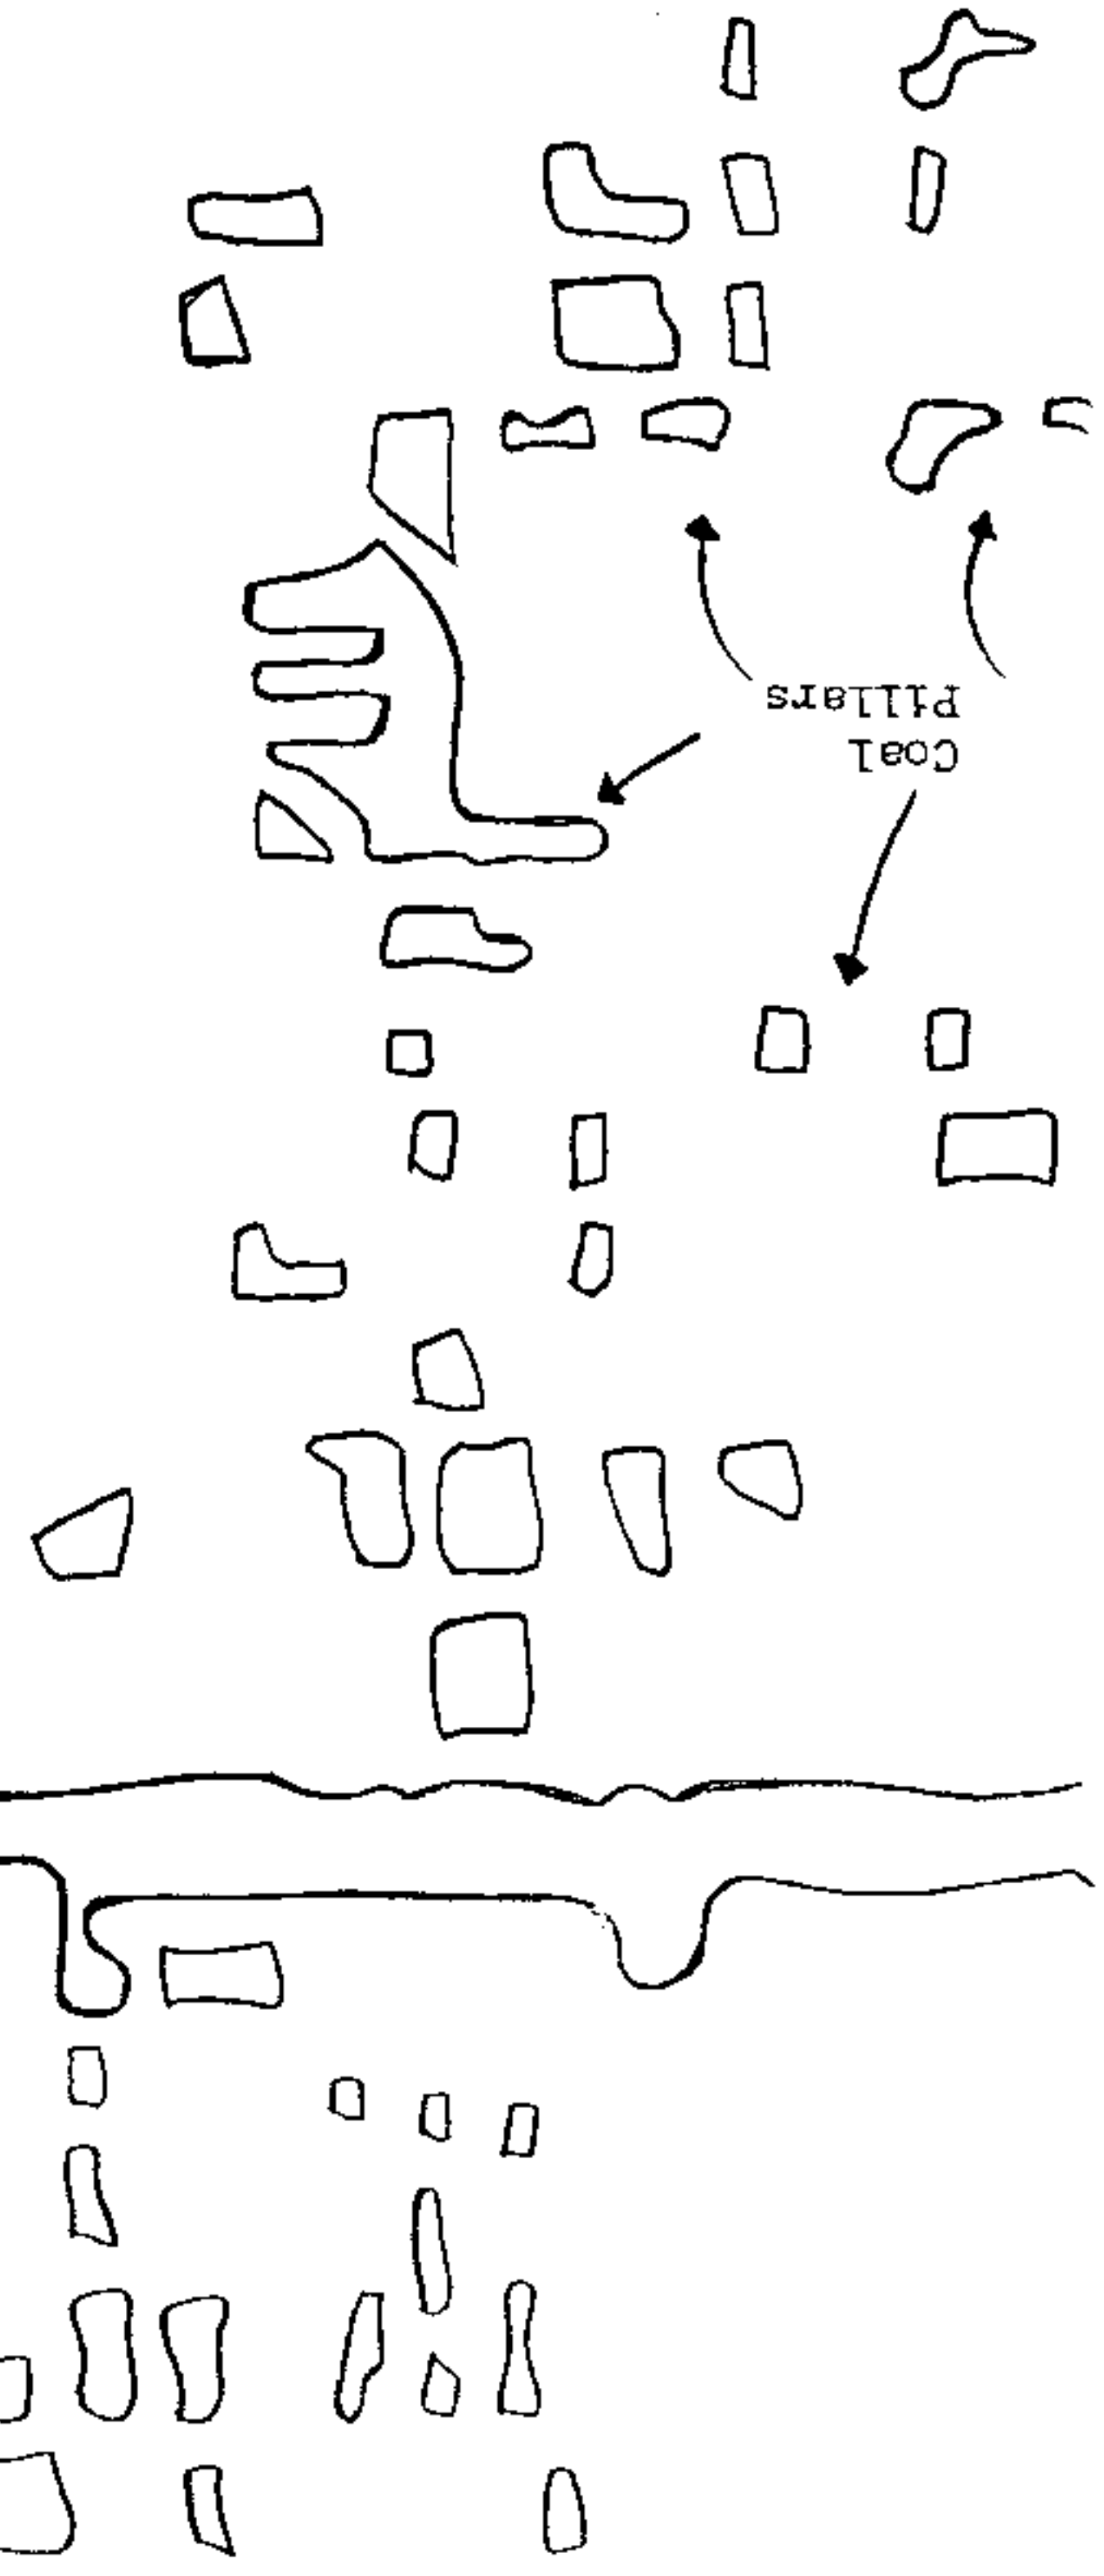
The system of development and extraction utilized in 1 butt left is shown in Sketch 2. The 1 butt left entry pillars were about 40 feet in width and 60 feet in length. The rooms involved were driven 20 to 30 feet in width, thus making the blocks (pillars) 30 to 40 feet in width and about 40 to 75 feet in length. The individual pillars are extracted by taking successive open-end lifts, 20 to 25 feet in width, across the back side of the pillars from the entry side of the entry chain pillars and from the room side of the room pillars; however, in some instances, the last lift (usually a push-out) is completed from the crosscut side of the pillars. After completion of the pillars in a panel of 5 rooms, the entry-chain pillars are extracted to a point opposite the No. 5 room then another panel of 5 rooms is developed, as illustrated in Sketch 2.

This system eventually establishes approximately a flat extraction line, but in the process development of rooms such as in the 1 butt left section is toward the gob in an abutment zone, and in some instances probably superimposed from 2 mined-out areas. (Old gob area from 2 butt left and the recently mined-out inby panel of rooms.)

Development and extraction of the coal in the 2 butt left territory was completed during the period of November 1956 to October 1958; however, the specific location of the 2 butt left mined-out area into which the rooms of 1 butt left (those involved in the bump) holed through, was completed during September 1958 or about a year previously. Reportedly, several remnants of pillars were left unmined in 1 butt left, and 2 butt left; locations of some of these are indicated in Sketch 2.
